THERMOGRAPHY INSPECTION FOR DETECTION AND TRACKING OF COMPOSITE CYLINDER DAMAGE DURING LOAD TESTING

J. N. Zalameda¹, W. P. Winfree¹, J. P. Seebo² and P. H. Johnston¹

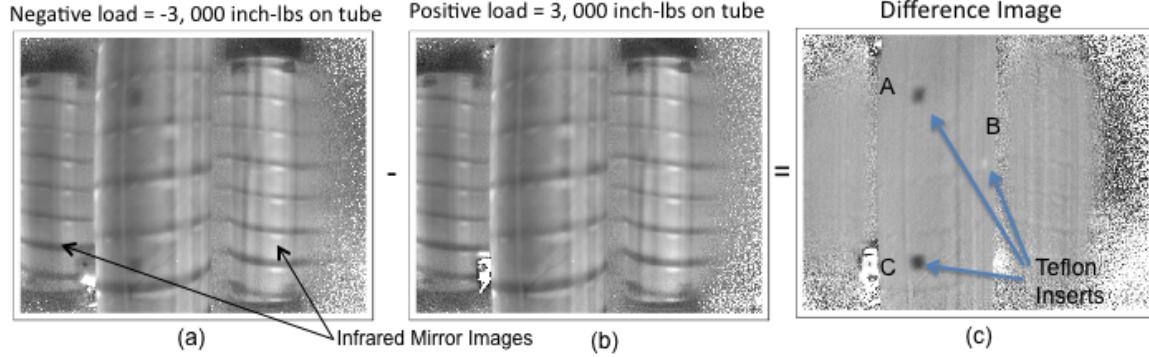
After a number of load cycles, typically around 50,000, a flash inspection was performed. Three flash inspections were performed: 0 inch-lbs static torsion load, + 3,000 inch-lbs static torsion load, and -3,000 inch-lbs static torsion load. For each static load, an effective thermal diffusivity inspection image was obtained. The effective thermal diffusivity image for the negative static load is shown in Fig. 3a and the top and bottom inserts A and B are detected as compared to the effective thermal diffusivity image for the positive static load shown in Fig. 3b where the top and bottom inserts, A and B, are not as apparent. For these inserts, the thermal contact resistance decreases (lower contrast) when a positive load was applied and increases (higher contrast) with a negative load. The difference in these measurements provides an image that shows all the Teflon inserts, Fig. 3c. The contact resistance change at insert A is seen in the measured temporal responses shown in Fig. 4a. When a negative static load is applied, the thermal diffusivity values

Figure 3. Differential thermal diffusivity imaging.

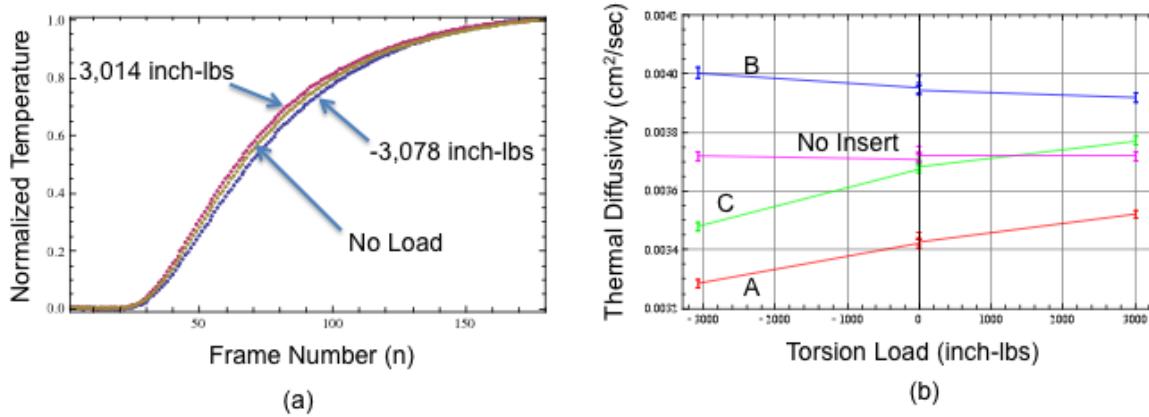
Figure 4. Change in temporal response at insert A and comparison of insert thermal diffusivity values as a function of static load.

at inserts A and C decrease and the thermal diffusivity value at insert B increases, Fig. 4b. The increases and decreases in the contact resistance, at the inserts, can be attributed to increases and decreases in the air gap. This data indicates the response in the cylinder depends on the composite layup in the region of the inserts.

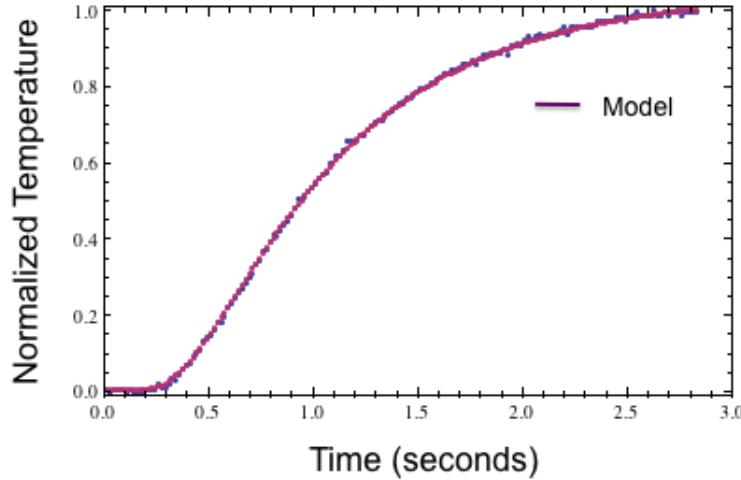
Figure 6. Multi-layered model fit to data at insert A with air gap.

The Fixed Talbot numerical inversion algorithm is used to solve for the temporal response of equation (1) [6]. The material property values used are shown in Table 1 for a nominal composite fiber volume fraction [7-9]. An example fit to the normalized data at insert A is shown in Fig. 6. The air gap thickness is measured with a negative static load applied. The estimated air gap thickness change at inserts A and C, due to cyclic loading is shown in Fig. 7. As shown, the air gap thickness increases as the number of fatigue cycles increases. This is due to the repeated opening and closing or exercising of the insert delamination during cyclic loading. The air gap over insert C appeared to grow faster as compared to insert A. This was perhaps related to a matrix crack that was detected using flash thermography at insert C. This is shown in the top right image in Fig. 7.

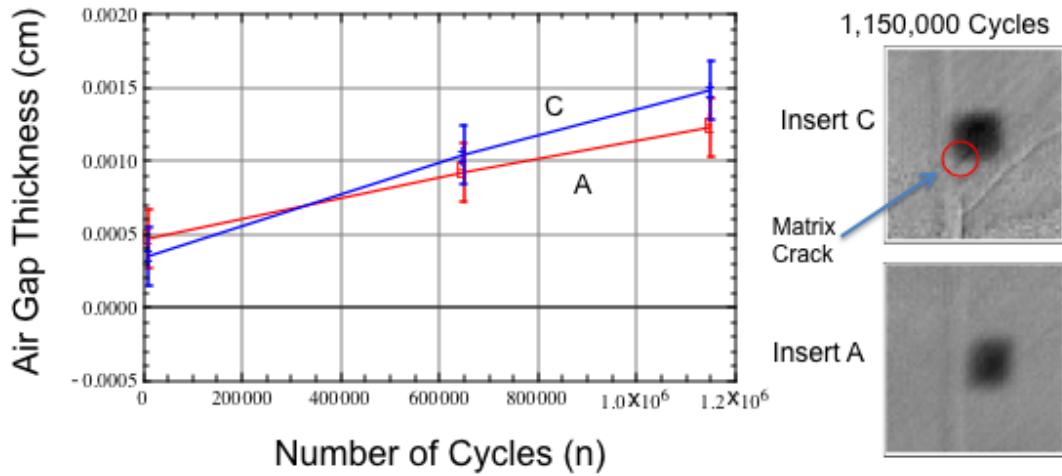
Figure 7. Estimated air gap change due to cyclic loading with flash inspection images.

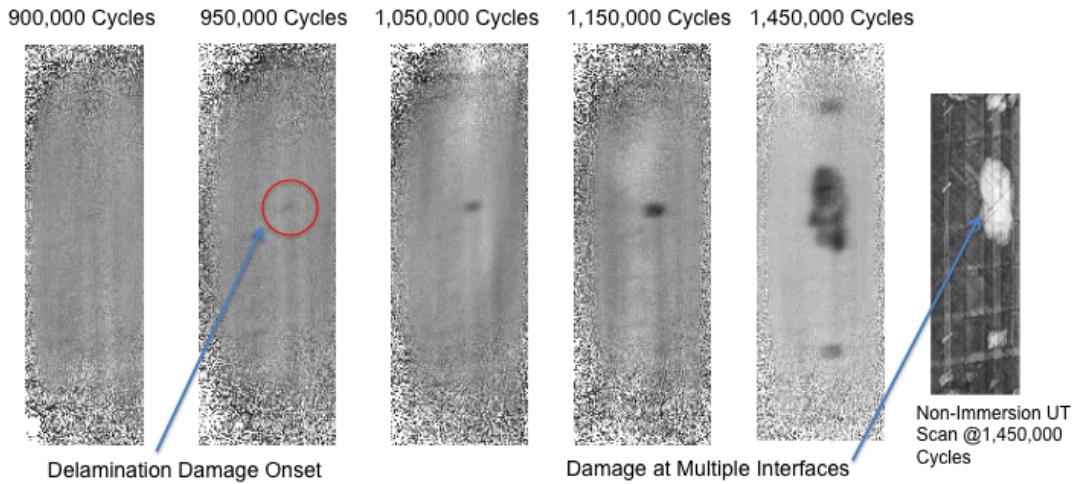
The flash thermography differential inspection results are shown in Fig. 8. Unexpectedly, the damage initiated on the right backside of the cylinder and not at the Teflon inserts. There was good agreement between the non-immersion ultrasonic image and the thermography results, Fig. 8. The non-immersion inspection used an ultrasonic transducer assembly comprised of an entrapped water column with a flexible membrane. The transducer assembly was mounted on the XY scanner to produce the inspection image. The ultrasonic inspection required about 2.5 hours to perform, and therefore, the thermography inspection (inspection time of several minutes) was used periodically to determine when an ultrasonic inspection should be performed. The ultrasonic inspection provides greater resolution of damage and at multiple interfaces.

Figure 8. In-situ flash thermography inspection of delamination damage growth.

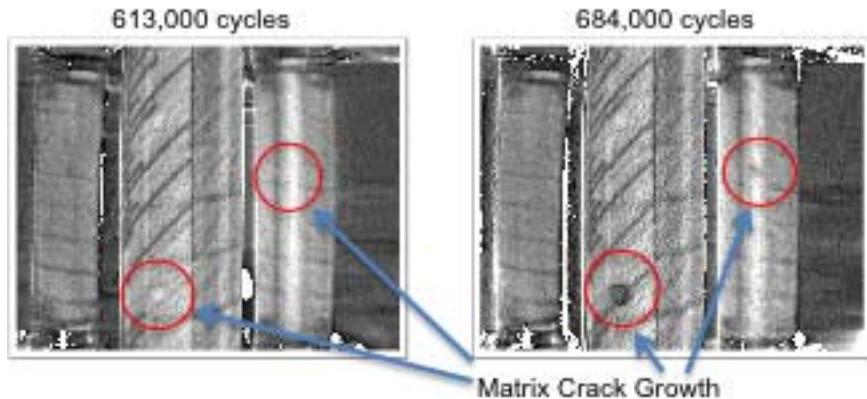
rubbing. Time domain processing using a principal component analysis data reduction algorithm was used to improve defect contrast and thus enhance visualization of the damage [5]. Examples of matrix cracks and delamination growth are shown in Fig. 9 and Fig. 10 respectively.

Figure 9. Example passive thermography results showing matrix crack growth.

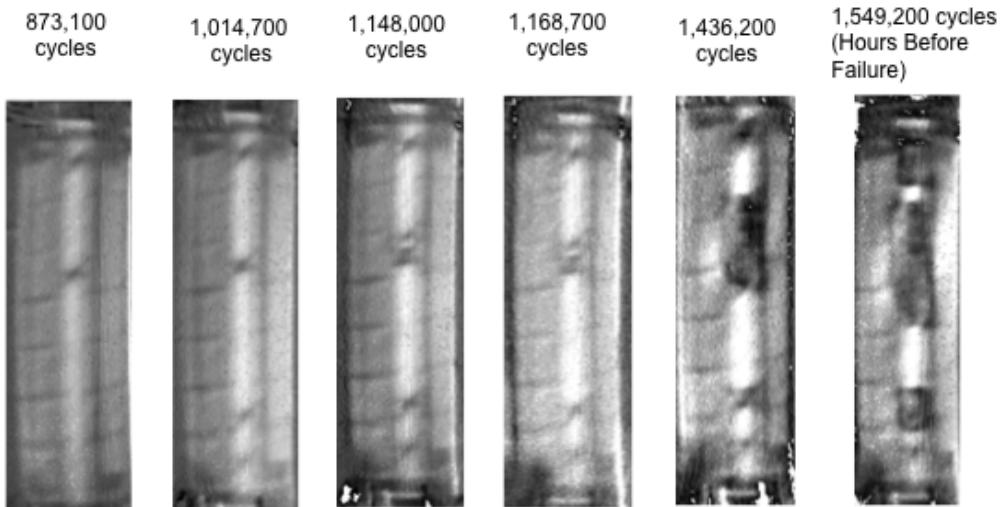
Figure 10. Passive thermography results showing delamination growth.
